Bulletin:

After Market LED Tail Lamp Correction

07/20/2016

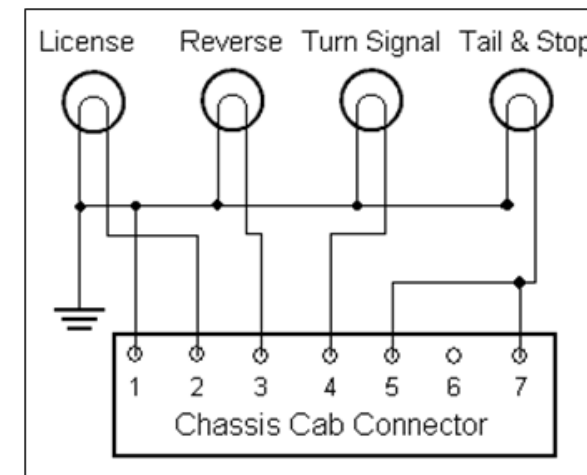
7.5.7. Aftermarket tail light installation

The purpose of this bulletin is to inform all Final Stage Manufacturers using Sprinters Cab – Chassis, Cutaway & Stripped Chassis (F50) model year 2007 & newer vehicles with retrofitted after market LED tail lamps installed according to the Body & Equipment Guideline for Sprinter 2015 and earlier model years, that certain conditions such as outage of LED turn signal lamps may lead to non-compliance with FMVSS / CMVSS 108.

The installation of a resistor in conjunction with after market LED tail lamps may disable the rapid flashing of the control light in the instrument cluster that provides notice an LED tail lamp is out, leading to the aforementioned non-compliance.

The depicted excerpt of the Body & Equipment Guideline for Sprinter 2015 and earlier model years (**see right**) should no longer be relied upon when installing after market LED tail lamps.

LED: When using LED's, a resistor must be used to compensate for the lower AMP draw. Turn signal LED's AMP draw must be between 1.75 A – 2.1 A otherwise rapid flashing will occur.
