Bulletin: Low Roof (Option Code FA 1)

09/08/2015

FA 1 - Information

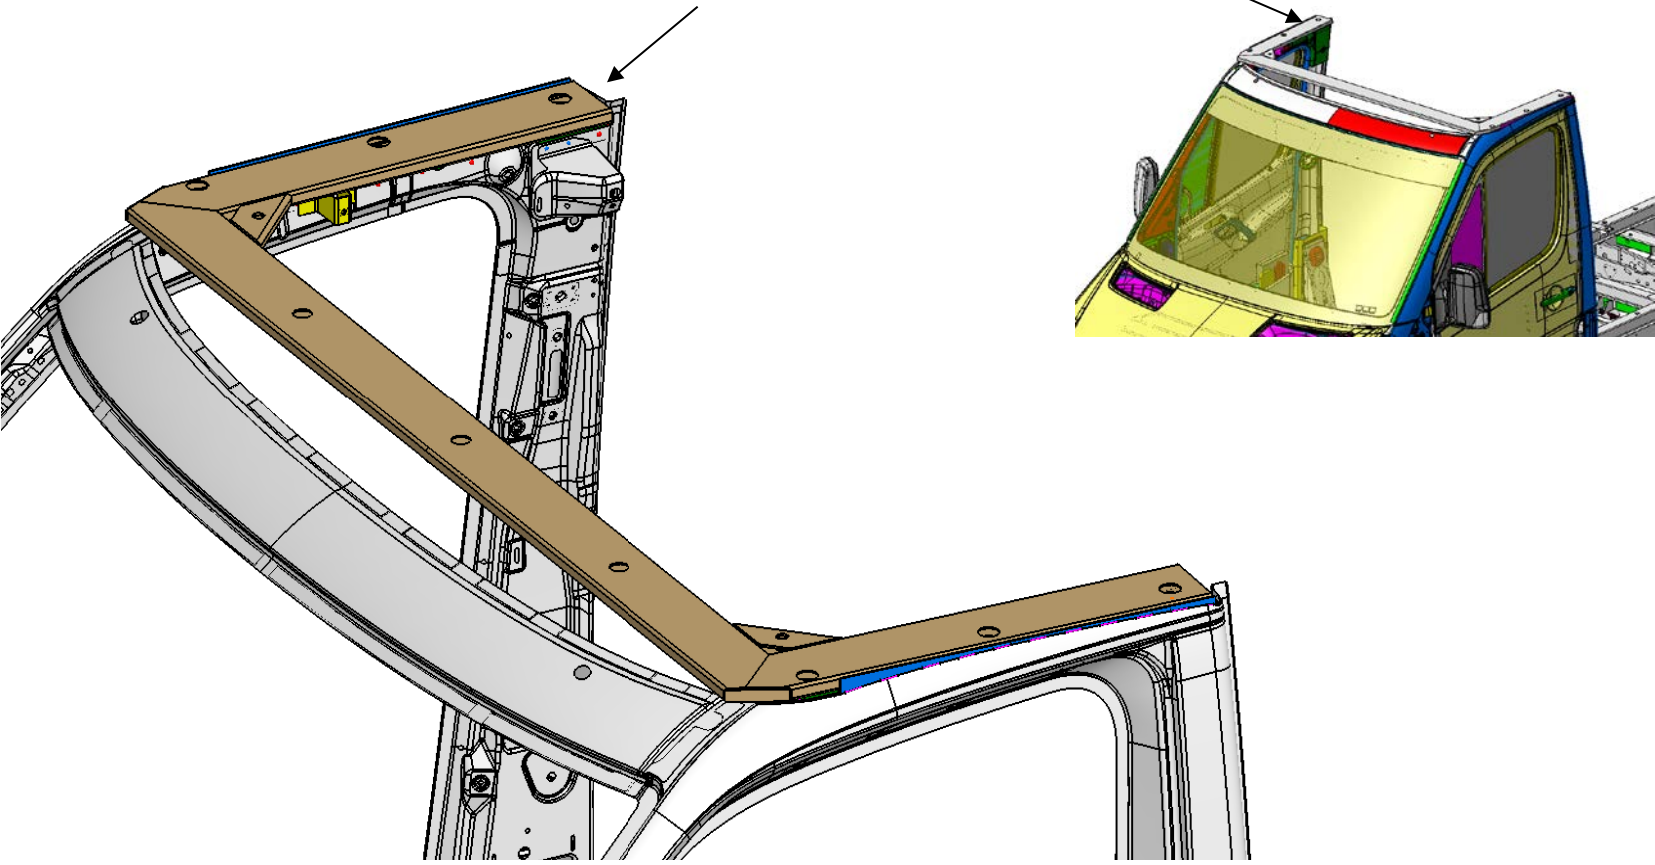
Reinforcement frame to compensate for structural integrity

Top of frame at Z=1595mm
(86mm - 3.4in lower than original roof level)

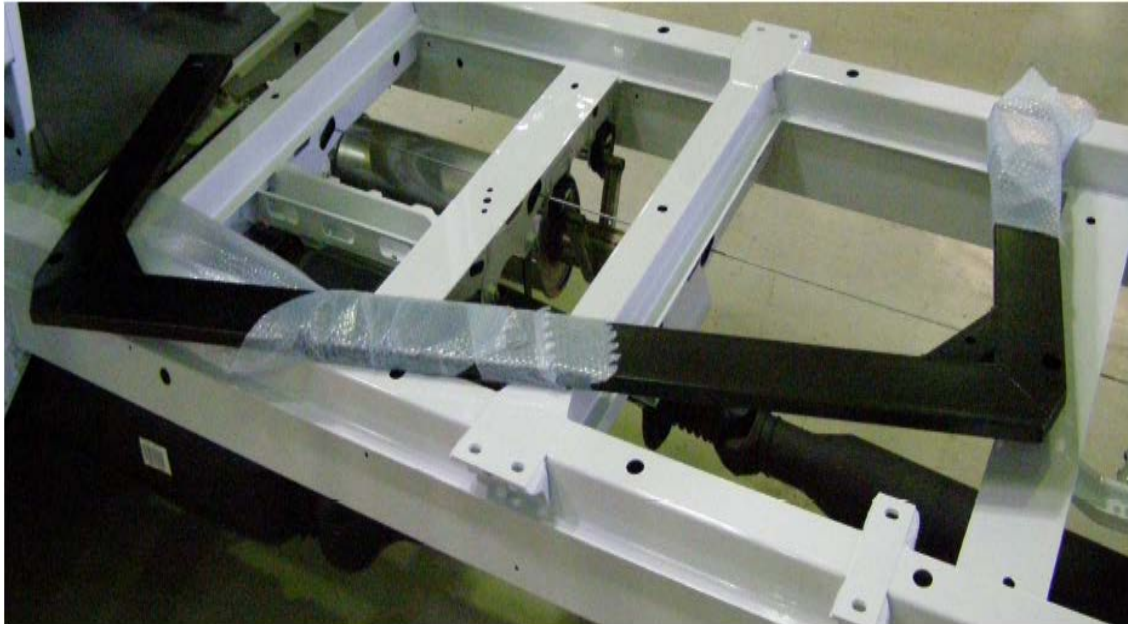
FA 1 - Information

Scope of delivery:

- Roof-bow bolted for shipping

Reinforcement frame to compensate for structural integrity

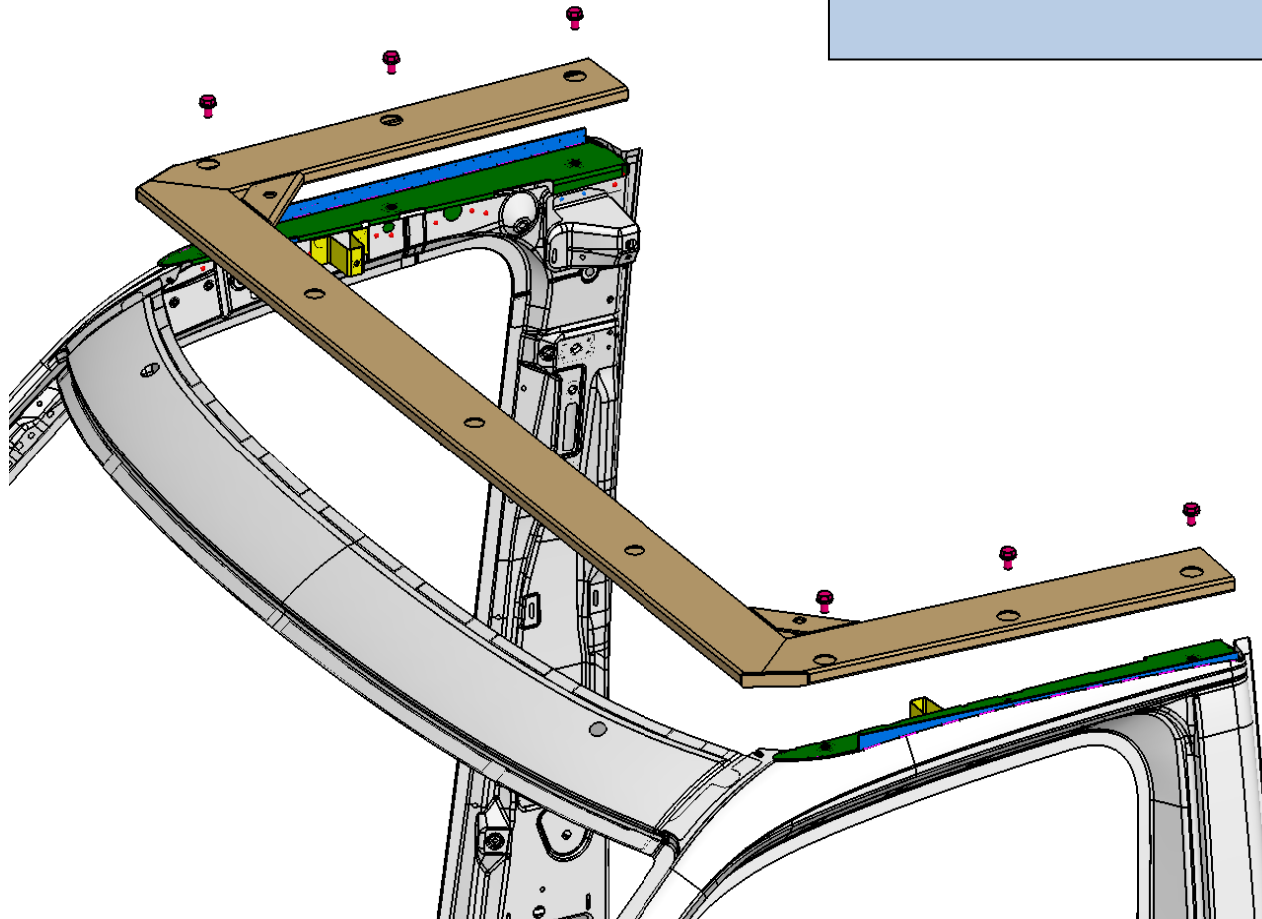
FA1 – Mounting Information

Part # N000000 004306 Hex Bolts MBN 10143-M10X 20-10.9-MK DBL9460.40 Qty 6

Torque: 40Nm +/- 2Nm → 29.5ftlb +/- 1.5ftlb

Bolting reinforcement frame (Upfitter)
